**RESTORATION
OF
MARY STANFORD LIFEBOAT HOUSE
RYE
EAST SUSSEX**

Prepared by: The Morton Partnership Ltd
Leonardo House
11 Market Place
Halesworth
Suffolk IP19 8BA

Date: October 2017

Reference: BAM\BEB\13168~restoration

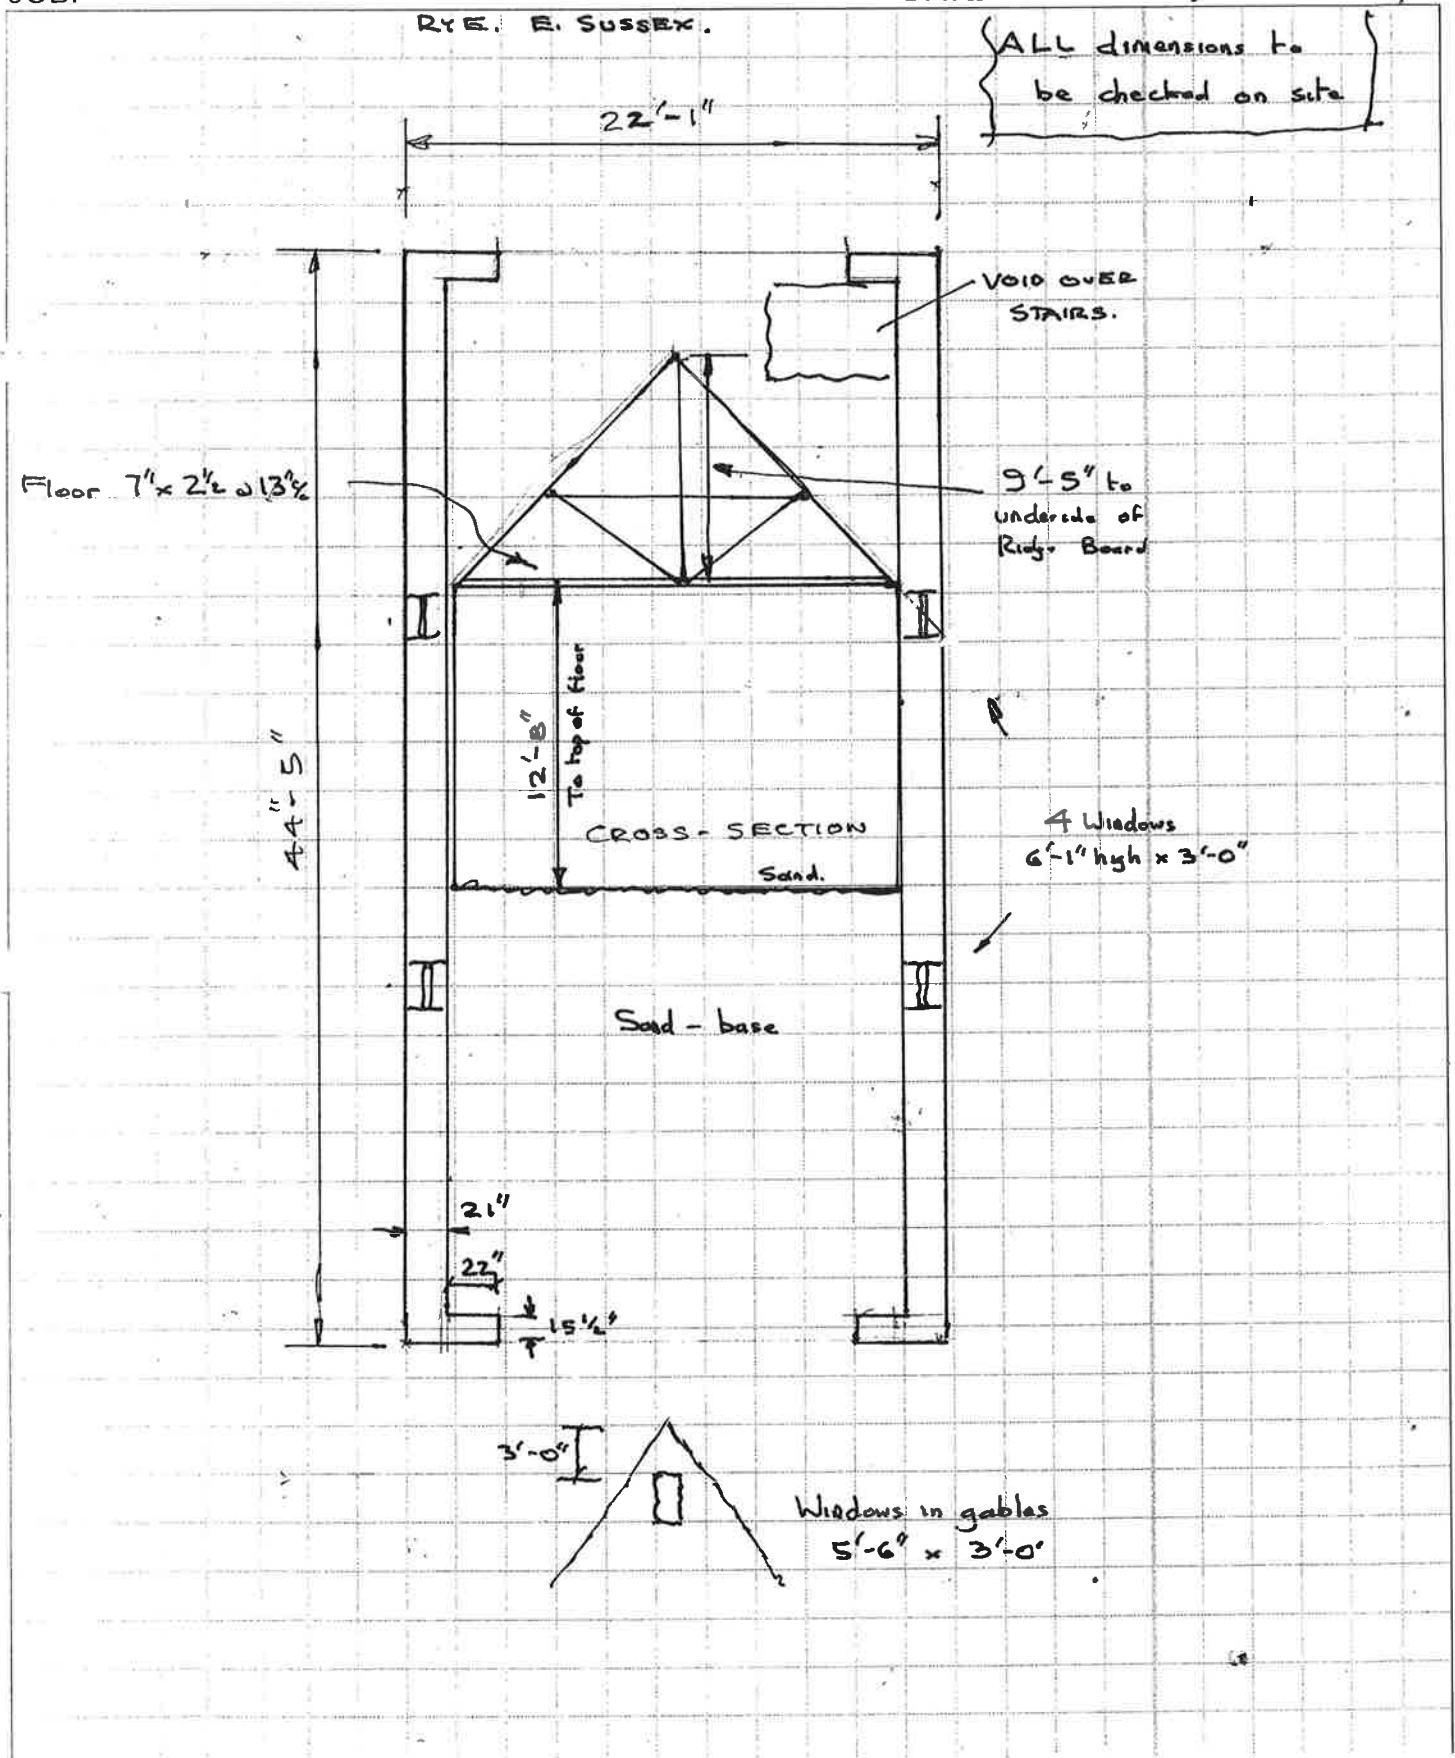
SKETCH N° 13168/AA/1.

- 2.6 A sketch plan with dimensional information will be found attached to this report in Appendix A with approximate dimensions in imperial measurements.
